**SCIENTIFIC ASSESSMENT OF
ENTRANCE BERM ELEVATION FOR
HEARNS LAKE, SANDY BEACH NORTH**

**Issue No. 2
JANUARY 2007**

**Patterson Britton
& Partners Pty Ltd**
consulting engineers

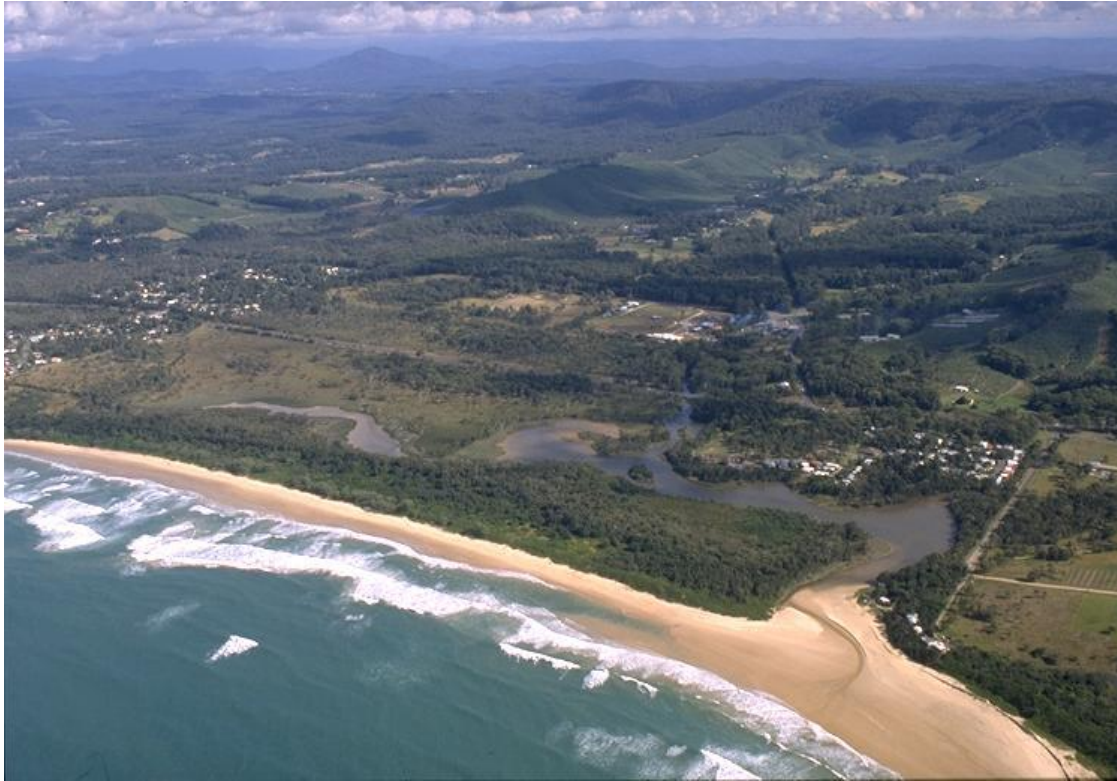
Plate 1 OBLIQUE AERIAL VIEW OF HEARNS LAKE SHOWING THE PARTIALLY CLOSED OCEAN ENTRANCE AND EXTENT OF THE DEVELOPMENT SITE

Hearn's Lake is an Intermittently Closed and Open Lake or Lagoon (*ICOLL*) which drains to the Pacific Ocean at the northern end of Hearn's Lake Beach. An oblique aerial view of the lake showing the ocean entrance in its partially 'closed' state is shown overleaf in **Plate 1**. The relative scale of the entrance berm is evident from **Plates 2** and **3**.

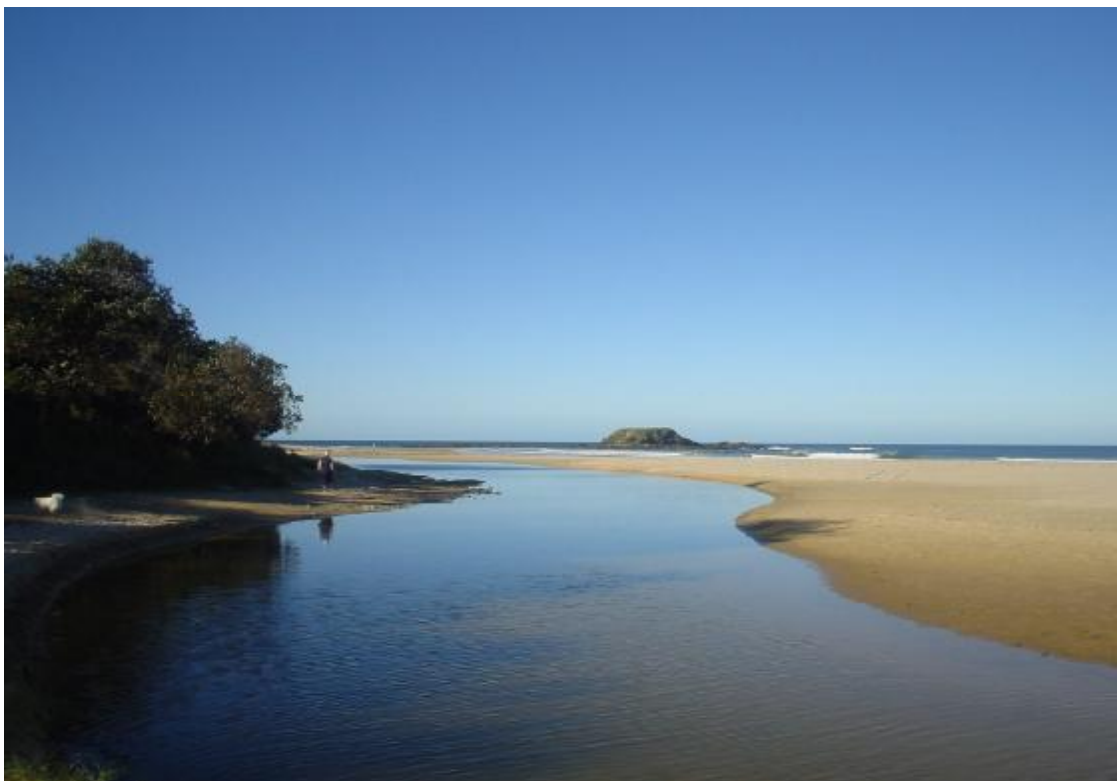
Plate 2 VIEW LOOKING SEAWARD FROM NEAR THE MOUTH OF DOUBLE CROSSING CREEK SHOWING THE RELATIVE SCALE OF THE BERM AT THE OCEAN ENTRANCE

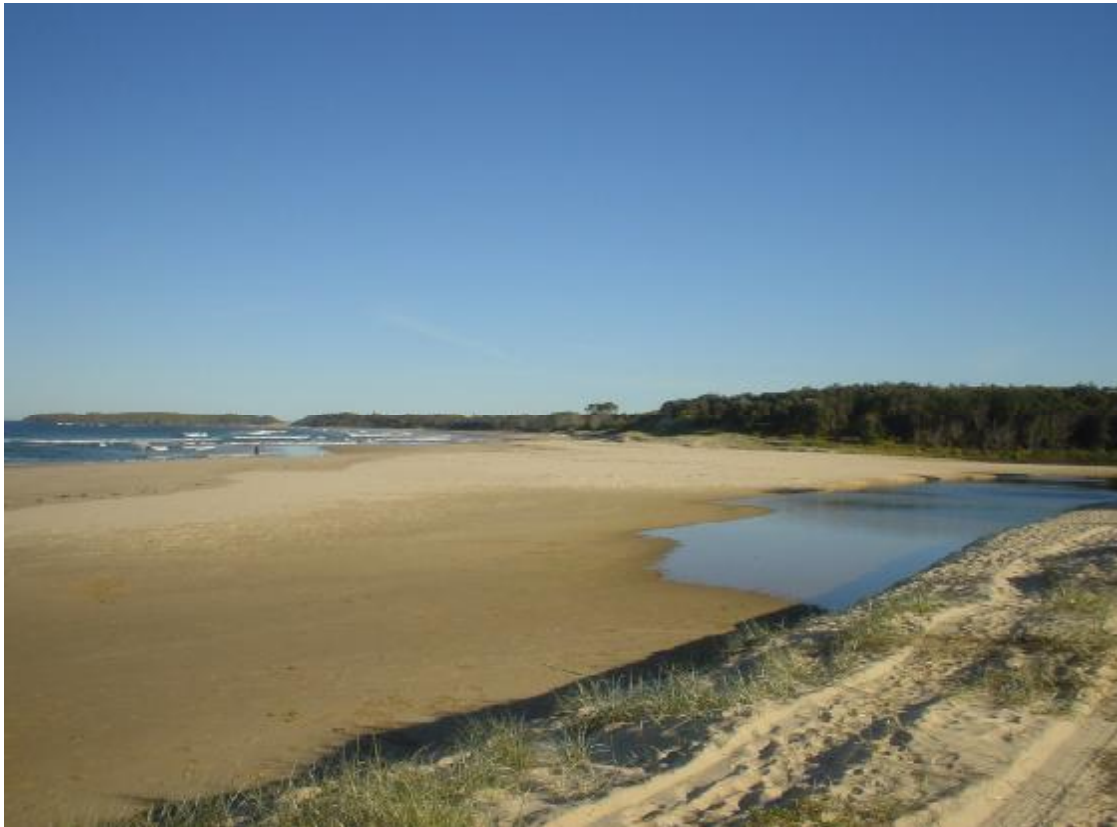
Plate 3 VIEW LOOKING SOUTH ALONG HEARNS LAKE BEACH SHOWING THE LIMITED DUNE FORMATION AND LOW ELEVATION IN THE VICINITY OF THE ENTRANCE BERM
